FTA Analysis of the Winding in Steam Power Plant: An Insight into the Stator

⁵Engineering System Owner Turbin, Rembang Steam Power Plant, Rembang, Indonesia

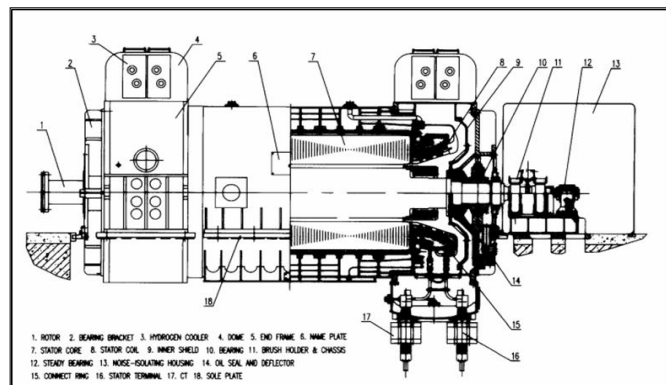
Figure 2. Generator anatomy of unit #20.

Figure 2 shows the sketch anatomy of the unit #20 generator in SPP RI. From the investigation results, the binding tape is aging, and the stator contains oil contamination (seal oil generator). It was obtained from the rotor maintenance history from DCS and visual findings in Figure 3. In addition, damage to the binding tape issue was found during an inspection of the stator side in the form of loose binding tape coils in several slots on the exciter and turbine sides (Figure 4); the earth stator fault alarm was also confirmed. In these conditions, it is fundamental to re-bind tape and conduct a bump test to degree the characteristic recurrence of the coiled stator. A stator coil component with a substandard frequency value would be strengthened on the coil side. Then, the bumping test was conducted. The results obtained from the bump test on both sides of both the exciter side coil and the turbine side coil are still in good condition, or the category meets the acceptable matrix standards of IEEE 1665-2009 [34].

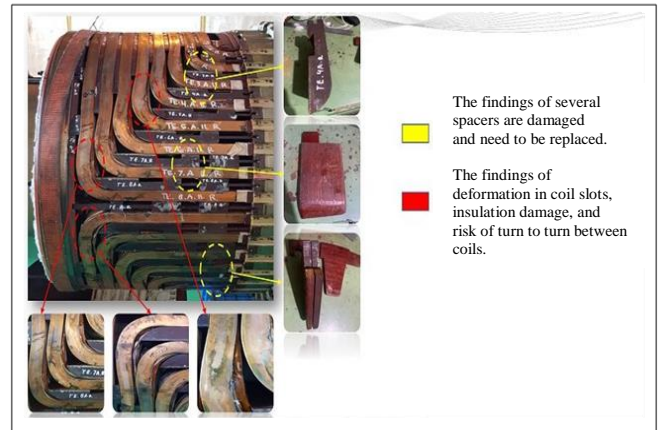
Figure 3. Winding coil rotor generator findings based on visual measurements.

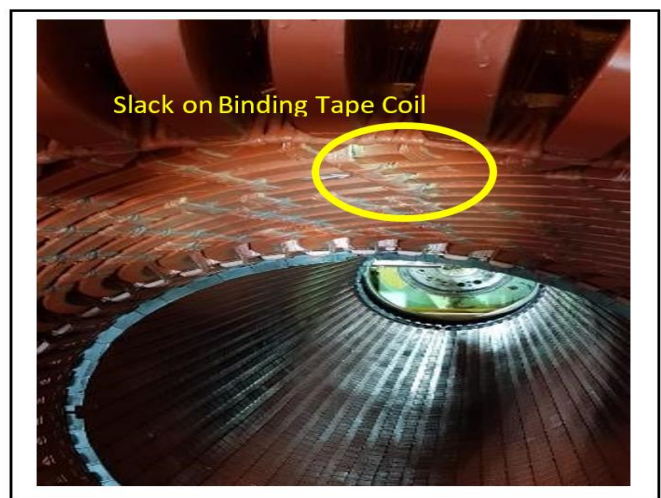
Figure 4. Slack on binding tape on the contents of the exciter as many as 75 points or 35% of the 216 points as well as the turbine side as many as 135 points or 62% of the 216 points.

Based on historical data of the operation in 2021 and visual measurements (Figure 4), where there are findings on the coiled stator in the form of binding tape (coil binder) at some point that is not tight (loose), it can be interpreted that the binding tape is experiencing aging conditions.

affects the condition of the generator, which is affected or the effect when the current surge is high due to short on the GCB so that vibrations occur and resonance arises in the core stator core, which has an impact on binding tape.

Based on these conditions, the binding tape undergoes slugging that cannot hold intact on the surface of the stator coil, resulting in continuous friction, which causes the insulation of the stator coil to erode. The erosion of the stator coil isolation would impact arching or flashover, so there is a short between cores.

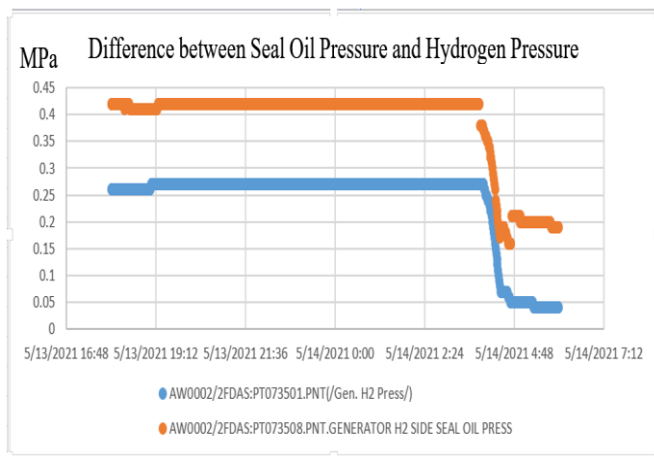
The most noteworthy plausibility of oil defilement within the stator is sourced from the Seal Oil Generator (SOG) framework, where the seal oil framework is closer to the internal zone of the stator. This anomaly within the seal oil framework can influence the cooling framework, in this case, hydrogen (H₂). Conditional pressure and flow settings on the oil seal would cause H₂ consumption to increase and would cause excess seal oil in the generator. Trending data of different seal oil and hydrogen pressure can be seen in Figure 5, showing the difference in seal oil and H₂ pressure and an average difference of 0.2 MPa.

Figure 5. Trending data of seal oil & hydrogen pressure.

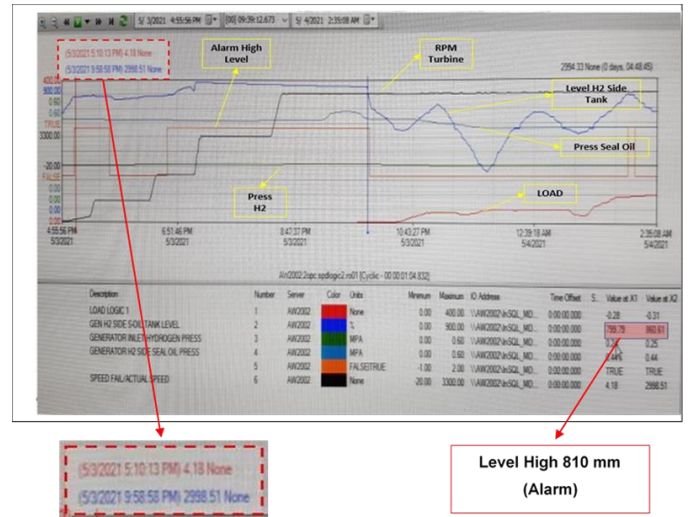
Operational conditions of the SOG system when start-up post-overhaul can be seen in Figure 6; the oil level of the H₂ side of the seal oil tank experiences a high level for ± 4 hours, which is likely that the seal oil does not circulate appropriately, so that the generator rotation is already high, it would cause oil splashes to enter the stator coil.

The oil supply that leads to the Air Side Seal Oil Generator (ASSOG) system has two manual valves connected. When starting the lube oil turbine (circulation) using the AOP (AC Oil Pump) pump after overhauling and not closing (close the valve/valve open), then most likely, the lube oil would fill into the side of the Air Side Generator (ASG) inlet pipe and can enter the generator. The weight depletes SOG moreover influences the passage of the seal oil, where in case the weight of the debilitate seal oil increments, the alteration of the oil seal on the depleted side is decreased so that the oil cannot circulate appropriately.

Figure 6. SOG system result indicates the oil contamination.

Recommendations for oil not to enter the winding stator include (1) H₂ level side tanks that need to make modifications related to logic at the h₂ side tank level by providing an alarm to the HMI so that it becomes an awareness to the operator when a high level occurs and the operation would maneuver; (2) valve supply seal oil that needs to be made sops related to the maneuvering of the valve supply seal oil at the time of firing so that the operator does not miss-maneuver; (3) pressure vacuum extractor that needs to be added to the alarm on the DCS logic and displayed on the HMI to become awareness in the operator when inappropriate pressure occurs; (4) the differential weight between the oil seal and hydrogen surpasses the standard, so it is vital to include parameters to the DCS related to the differential weight between the oil seal and hydrogen so that when it is exterior the standard, there's a caution and gets to be mindfulness for the administrator; (5) drain switch level that needs to be checked periodically regarding the level of drain oil/water switch to ensure the condition of the equipment.

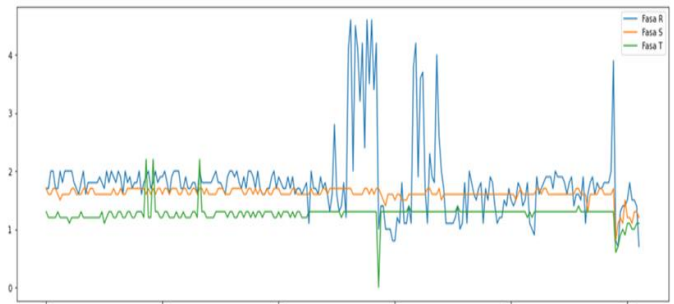
Figure 7 shows the partial discharge (PD) measurements (online). Results show no significant increase in each phase related to partial discharge, which was still below 5 Pico Coloumb. The online PD data in the picture shows a difference in values between offline PD performed during overhauling. Therefore, it is necessary to inspect the rules for measuring instrument equipment. The data in Figure 7 is taken by removing some data when the unit is not voltage, and the data is processed first to ensure measurements at the same hour in the three phases.

Figure 7. Trending data of partial discharge online.

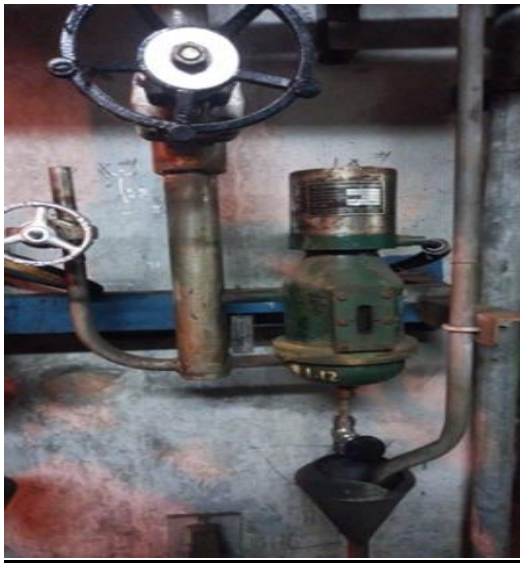
The condition of the leak drain sensor (Figure 8) is damaged, making it unable to drain automation when there is a complete oil or water level. Damage occurs to magnets inside the switch-level equipment.

Figure 8. Leak drain sensor that broken.

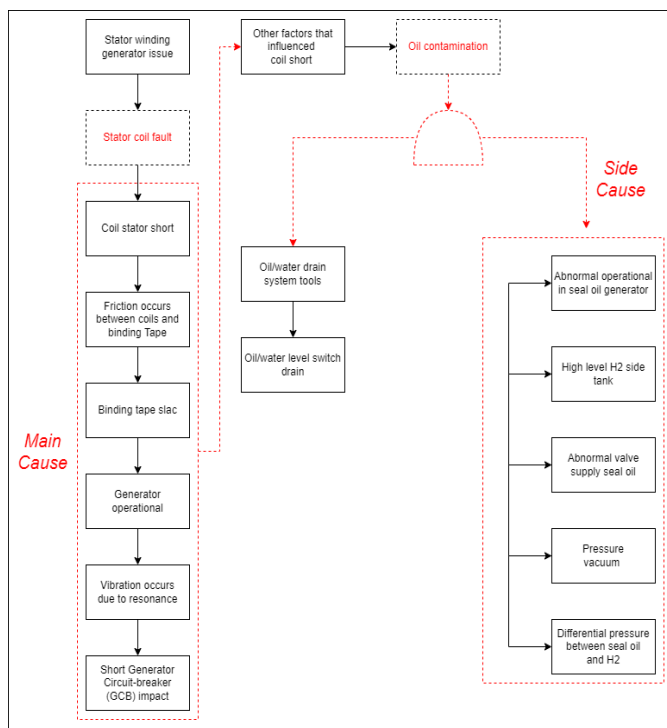
Figure 9. Results of Fault Tree Analysis (FTA) of stator winding issue.

Based on the complete inspections, the Fault Tree Analysis (FTA) results on the stator winding fault can be seen in Figure 9. In addition, FTA results related to early indications of stator winding interference can be seen in Figure 10.

- 1) The initial parameter that detects the initial condition of deterioration of stator winding fault is the “Earth Stator Fault Alarm.”

- 2) Factors causing failure of the winding stator:
 - a. Leading cause: the condition of the insulation tape has begun not to bind,
 - b. Side cause: high hydrogen side tank level (over a long period), valve supply seal oil is abnormal, vacuum extractor pressure is abnormal, and the differential pressure between seal oil and hydrogen exceeds the standard.

Recommendations related to the results of the Fault Tree Analysis (FTA) include: (1) if there is an alarm earth stator fault, it is necessary to carry out inspections related to binding tape coil & insulation of generators at the 3rd assessment level; (2) take precautions by ensuring that there is no oil entering the winding stator.
