Study on Safety of Pedestrian at Mid-block Crossings in Urban Areas of Developing Countries

Badveeti Adinarayana^{1*}, Mohammad Shafi Mir²

^{1,2}Dept. of Civil Engineering, National Institute of Technology Srinagar, India - 190006

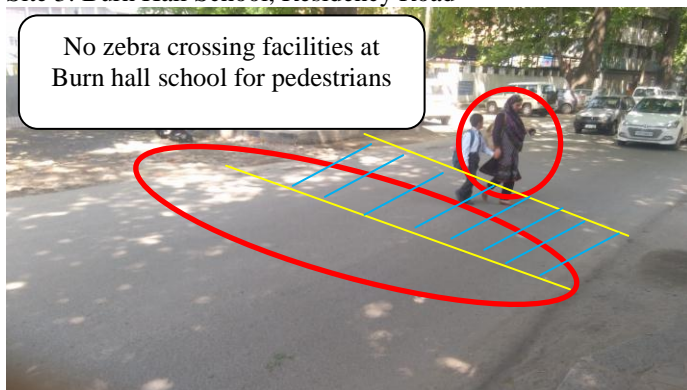
Site 3: Burn Hall School, Residency Road

Figure 3. Midblock Crossing at Burn Hall School, Residency Road
(Source: Captured by camera on 24/04/2018)

- Poor visibility of the road markings for the pedestrian at the midblock crossings.
- Absence of traffic signs.
- Absence of traffic signals.
- Absence of STOP line and road humps.
- No special provision for the physically disabled people.
- Speed of the traffic is high so that pedestrian face lot of difficulties while crossing the road especially during the peak hours.
- Surface condition of the road is not good. It becomes slippery in wet condition.

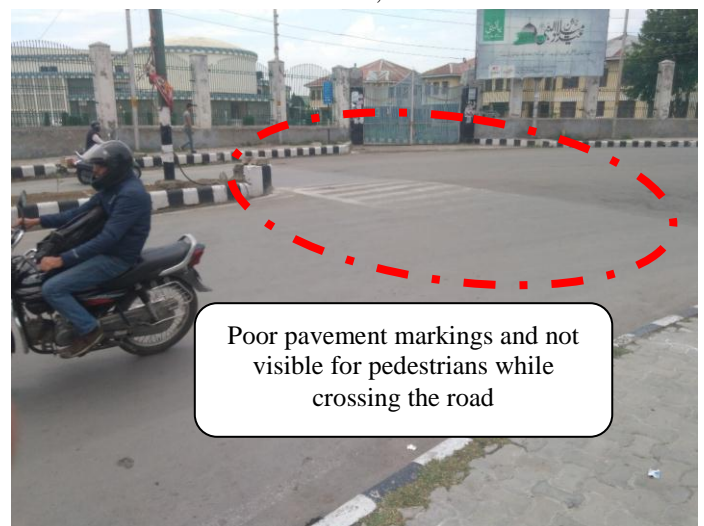
SITE 4: Hazratbal Road, Near KU

- Insufficient space for on-street parking.
- Average crossing speed is 1.2 to 1.55m/sec
- Width of the road :21.10 m
- Dimension of the midblock: 2.46 m x 0.4 m
- Spacing of the midblock strips:0.4 m

- Absence of road marking.
- No special provision for the physically disabled people.
- Absence of traffic signals.
- Absence of STOP line and road humps.
- Speed of the traffic is high so that pedestrian face lot of difficulties while crossing the road especially during the peak hours.
- Traffic volume is also high due to nation highway (Srinagar-Leh Highway).
- Surface condition of the road poor.
- Width of the road :7.2m

Figure 4. Mid-block crossing at Hazratbal Road, near KU
(Source: Captured by Camera on 22/04/2018)

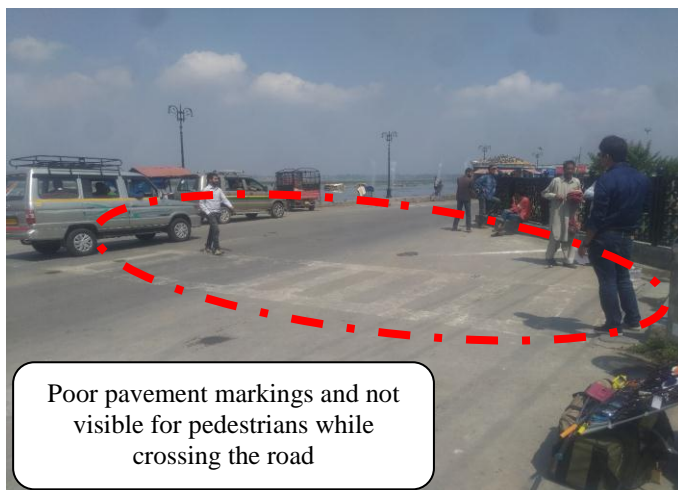
SITE 5: Nishat Garden

- Poor visibility of the road markings for the pedestrian at the midblock crossings.
- Traffic signs are not visible.
- Absence of traffic signals.
- Absence of STOP line and road humps.
- Speed of the traffic is high so that pedestrian face lot of difficulties while crossing the road especially during the peak hours.
- Surface condition of the road is good. It becomes slippery in wet condition.
- Insufficient space for on-street parking.
- Width of the road :19.84m
- Dimension of the midblock: 2.46 m x 0.4 m
- Spacing of the midblock strips: 0.4 m

Figure 5. Mid-block crossing near Nishat garden
(Source: Captured by Camera on 22/04/2018)

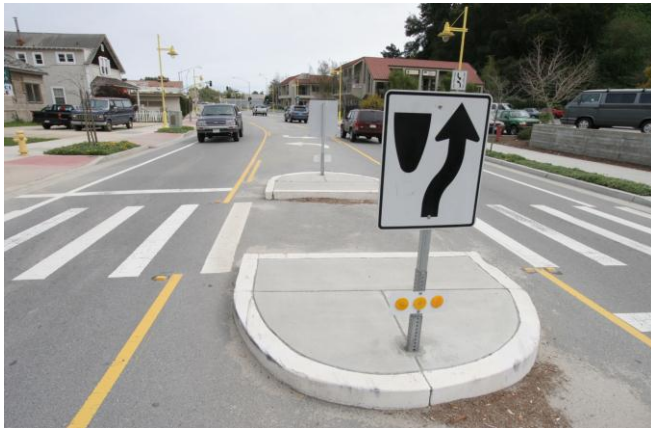
Refuge islands are raised medians placed in the centre of the roadway at midblock locations. Refuge islands are intended to assist pedestrians in crossing wide streets by providing a safe “refuge” in the centre of the road, allowing pedestrians to cross one direction of traffic at a time. The presence of a refuge island reduces the time a pedestrian must wait for an adequate gap in the traffic stream and reduces the crossing distance that they must face at one time. Pedestrian refuge islands are particularly suitable near pedestrian generators such as hospitals, schools, malls, etc., and may form part of a larger street scraping plan.

Figure 10. Refuge Island (Source:<http://www.tcat.ca/wp-content/uploads/2016/07/pedrefugeilsand.jpg>)

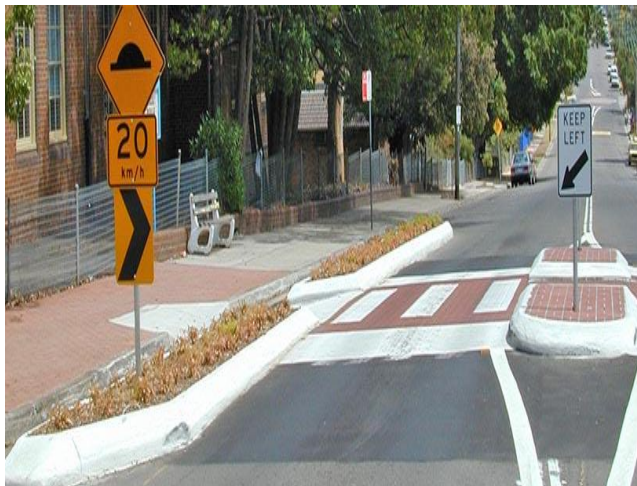
Kerb extensions “extend” the sidewalk or kerb line at specific points to reduce the width of the travelled portion of the roadway or extend out into the spaced allocated for kerb side parking. Kerb extensions reduce the distance pedestrians have to walk, hence pedestrians require smaller gaps in traffic in order to cross and pedestrian delays are likely to be shorter. Kerb extensions can provide a refuge for pedestrians, improve the sight distance and sight lines for both pedestrians and motorists, and may also be considered as a traffic calming measure.

Figure 11. Kerb extension (Source:<http://www.roadsafety/wp-content/uploads/2016/07/pedrefugeilsand.jpg>)

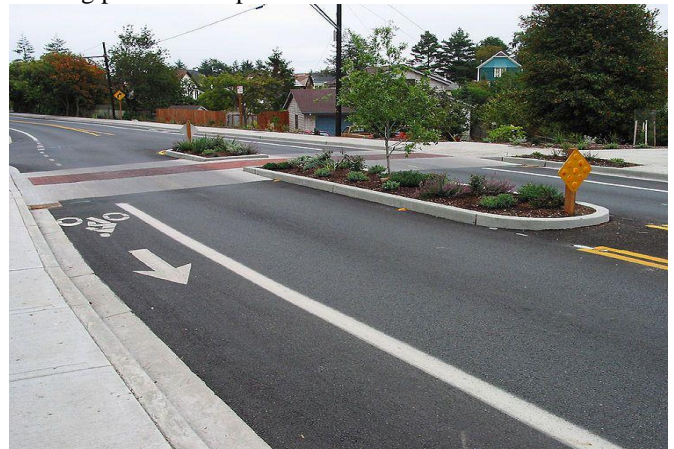
A raised crosswalk is a marked pedestrian crossing point at an intersection or mid-block location constructed at a higher elevation than the adjacent roadway. The raised surface improves drivers’ awareness of the potential for pedestrians and has a traffic calming effect as one of its effects is to reduce speed. Raised crosswalk applications should be

considered within the context of the road authority’s traffic calming policies and practices.

Figure 12. Raised crosswalk (Source:<http://wp-content/uploads/2016/07/pedrefugeilsand.jpg>)

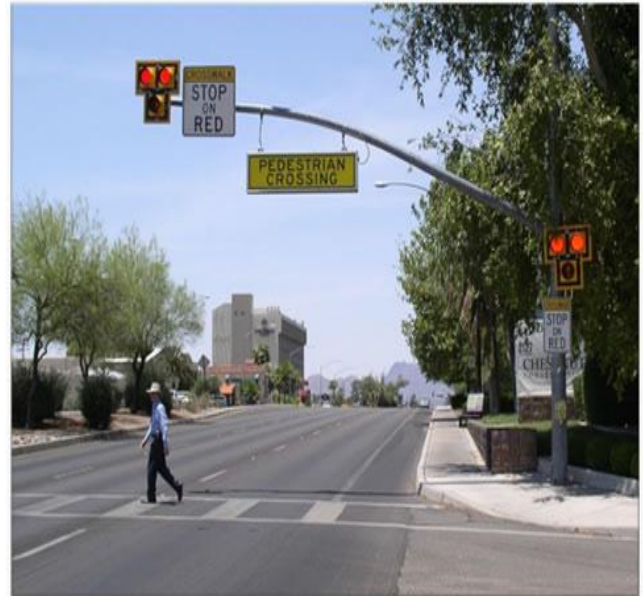
Warning signs are used to alert drivers to danger or potential danger ahead. They indicate a need for extra caution by road users and may require a reduction in speed or other man oeuvre. This section contains advice on when to use each sign. Adequate warning signs can greatly assist road safety. To be most effective however, they should be used sparingly.

Figure 13. pedestrian warning signs (Source:<http://warningsign/uploads/2016/07/pedrefugeilsand.jpg>)

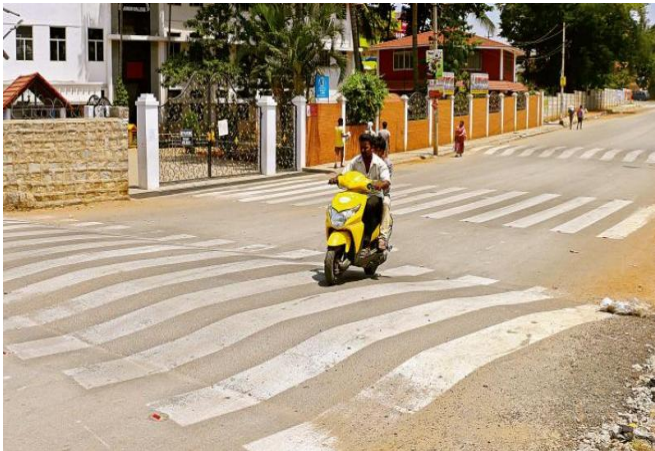
These are the small undulations which are made on the surface on the road, due to which drivers of the vehicles are forced to reduce the speed of their vehicles.

Figure 14. speed breaker (Source:<https://s3.ap-southeast-1.amazonaws.com/images.deccanchronicle.com/dc-Cover>)

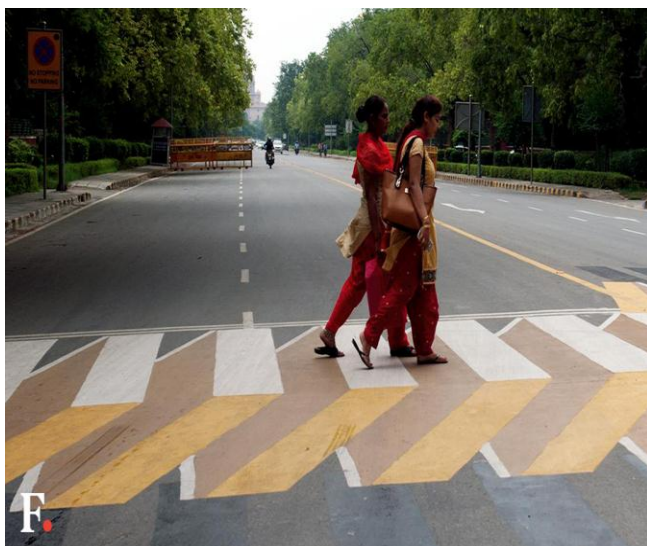
This type of paint can be used to give an illusion of some obstruction to the driver when he is speeding up.

Figure 15. 3D Paint

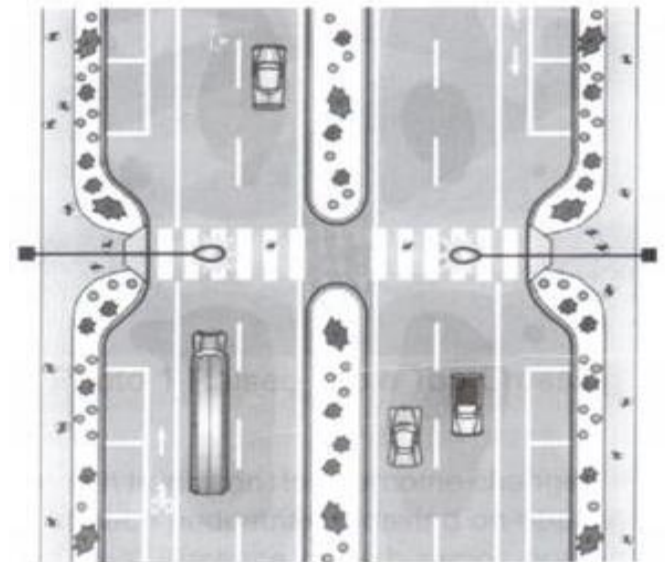
Figure 16. Midblock crossing kerb extensions (Source: Guidelines for pedestrian facilities, IRC 103-2012)
